User Inspection Notice

MSA V-EDGE® Web PFLs

August 2025

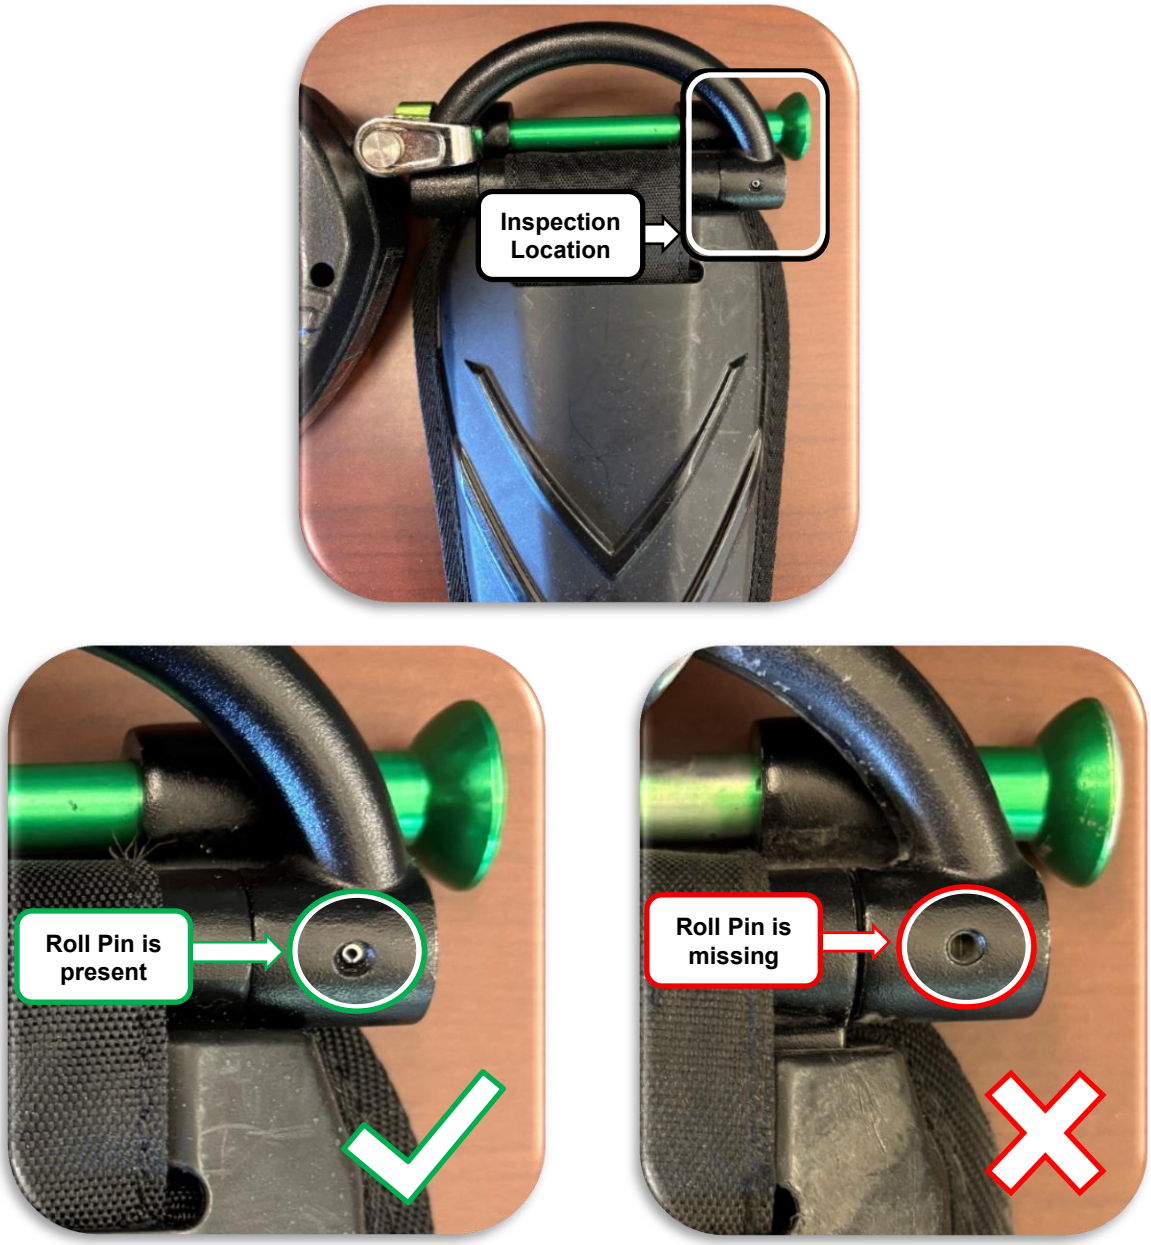
Figure 3: Roll Pin Inspection

MSA has received an isolated field report that a bolt that connects the PFL ring to the Energy Absorber of the V-EDGE Web PFL separated from the unit, resulting in the unit being non-functional. MSA has not received any reports of injuries associated with this condition. However, we request that you perform the inspection outlined in this notice prior to your next use and include it in your pre-use checks and examination procedures.

2) **Inspect the product** - Visually inspect the bolt that connects the PFL ring to the Energy Absorber of the V-EDGE PFL for the presence of the silver roll pin. (Figure 3)
    a. Roll pin is present and flush – Continue using product per manufacturer recommendations.
    b. Roll pin is protruding or not present – Remove the product from service and follow the procedure below for a replacement unit.

Inspect all units per the instructions in this notice prior to your next use. If any PFL does not pass this inspection, remove it from service and contact MSA.

If you are in possession of any MSA V-EDGE Web PFLs whose roll pin is not properly secured, we will replace them free of charge. In an effort to minimize any disruption, we pledge to take any replacement actions as expeditiously as possible.
